U. S. FOREST SERVICE
RESEARCH PAPER NC-16
AUGUST 1967

HARDWOOD SIDING PERFORMANCE

GLENN A. COOPER

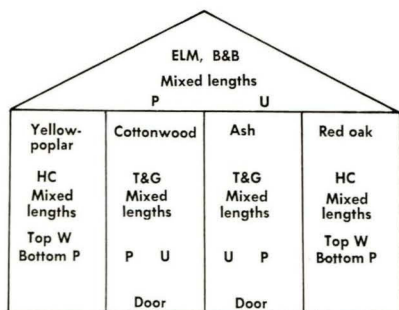
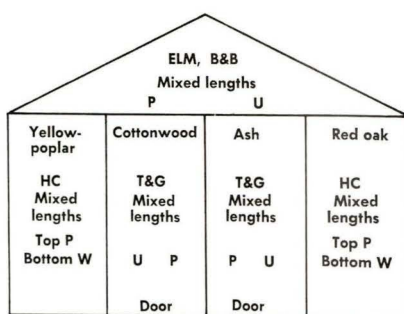
Figure 1.—Species, style, board length, treatment, and location of the test panels. Styles were T&G (tongue-and-groove), B&B (board-and-batten), and HC (horizontal clapboard). Treatments were P (pentachlorophenol), W (water-repellent penta), and U (untreated).

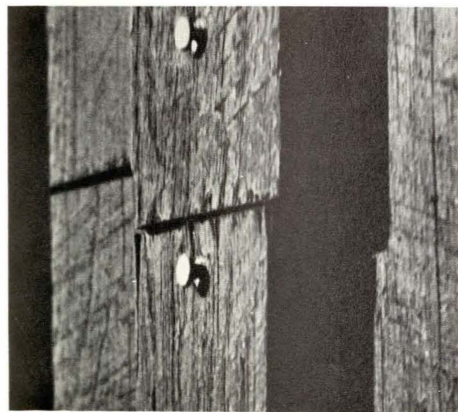
F-516581

Hickory was intermediate in performance. Thirteen percent of the total joint length in the panels leaked. These leaks were chiefly due to warping of the battens. Six percent of the hickory siding parts had splits, slightly more of them in the battens than in the boards. Three percent of the nails popped, most of them in battens (fig. 2). Eighty percent of the panel surface area was checked, and the checks were longer and deeper than in red oak.

Figure 2.—Popped nails in hickory battens. Most popped nails were not this far out.

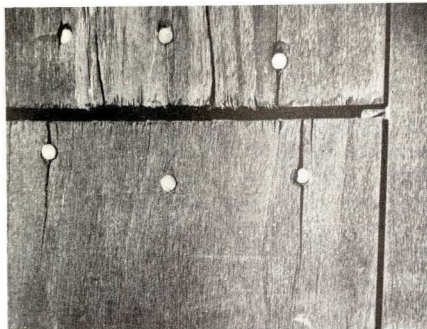
F-516582

Sycamore performed noticeably poorer than any species except beech. The untreated sycamore joints leaked along 30 percent of their total length, partly because of considerable warp of the battens. Nail popping (6 percent) and checking (60 percent) were about the same as for soft maple. Splitting (20 percent) occurred mainly as a few long splits (fig. 3).

Figure 3.—Sycamore board-and-batten siding, untreated, south wall, with long mid-board splits.

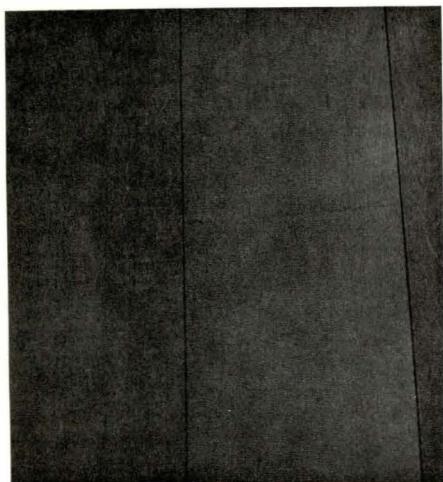
F-516587

Differences in the red oak and yellow-poplar siding styles were clearly evident. Tongue-and-groove siding was the most watertight (figs. 8 and 9). Only one leak in the 16 test panels occurred, and this was due to tongue breakage during installation. There was less water staining on the inside of these panels than in the other styles because the

Figure 8.—Yellow-poplar tongue-and-groove siding, water repellent treatment on the south wall. The boards have shrunk exposing 3/16 inch of tongue, but the joint is tight.

1. For maximum weathertightness use full-length, vertical tongue-and-groove yellow-poplar or red oak siding, dip-treated in a

water-repellent preservative, and installed bark side out.

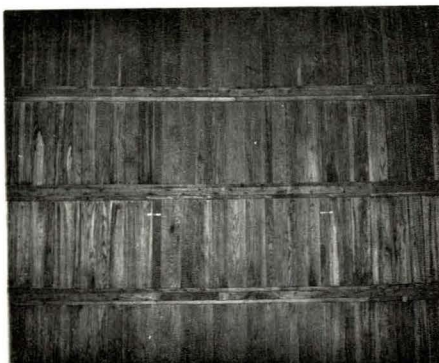
F-516589

An outstanding difference due to treatments was the amount of water stain on the inside of the panels (see fig. 11). In all siding the water repellent-penta treated boards were almost free of stain, whereas all the untreated and penta treated panels had considerable stain on the inner faces.

Figure 11.—Water has stained the inner faces of the penta-treated (left) and untreated (right) portions of this red oak mixed-length tongue-and-groove siding. The water-repellent penta-treated portion (center) has no stain. Free water was not observed on any of the portions after rains. Stain is therefore attributed to moisture wicking through butt and edge joints.
